Parking Report - Dudley Square
July 13

RUGGLES STREET PARKING LOT (1) ROXBURY

REVIEW OF CONSTRUCTION DETAILS

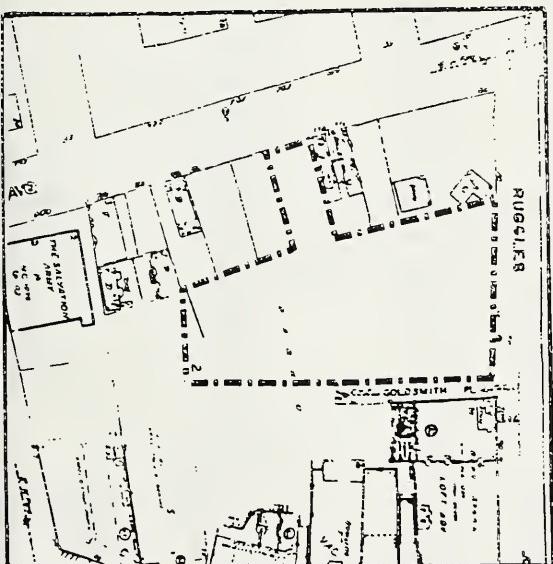
This 72 car parking lot is located behind a group of commercial buildings facing Washington Street. The lot is not visible from Washington Street, and is presently a vastly underused facility.

The lot is bounded primarily by vacant rubbish-filled lots and appears to be used mostly by tenants at 25 Ruggles Street.

This parking lot is of first class construction with granite curbs, cobble overhead lighting and several trees. The lot has suffered some damage by truck movement to adjacent dumpster.

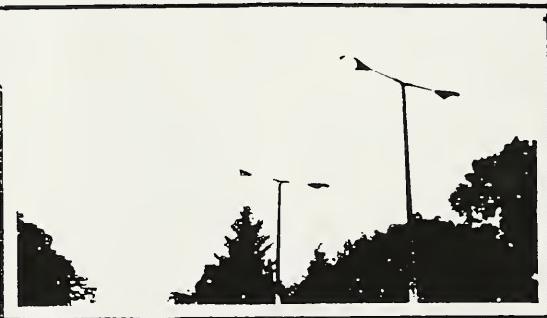
CATCH BASINS are in good condition and in need only of general cleaning.

LIGHTING consists of double overhead cobra lights. Several lights were on in the daytime suggesting a need to review the condition of the wiring.

- Replace damaged fencing.
- Remove unnecessary fencing.
- Replace damaged paving.
- Repair overhead lights.

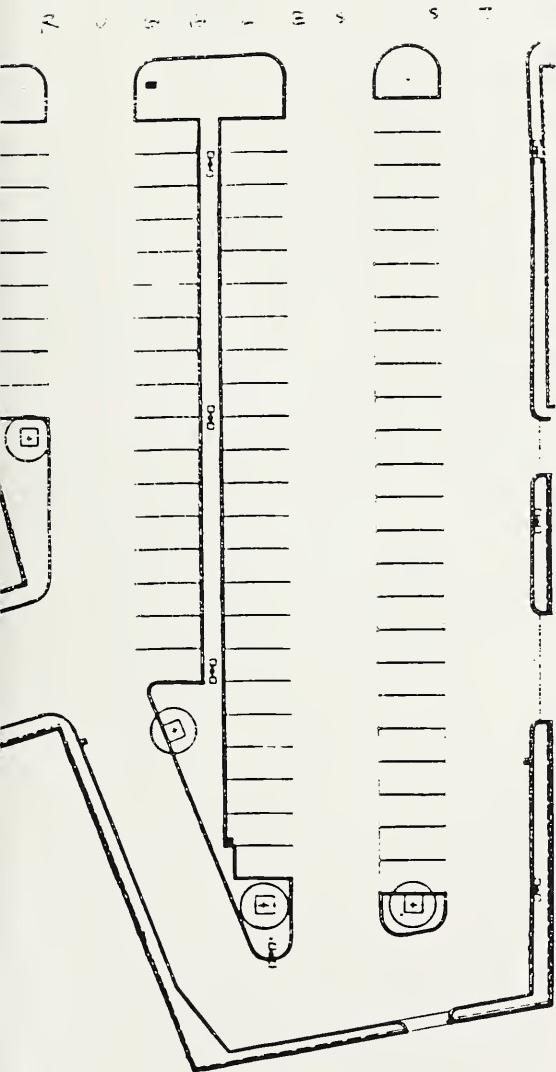
DEBRIS, primarily a result of illegal dumping, should be cleaned up to improve the general appearance and to reduce the potential for additional dumping.

Extra effort should be made to clean up the adjacent streets and vacant lots. Since considerable effort will be required, and a substantial quantity of trash will be accumulated, it is suggested that the clean-up be gradual over the entire summer period.
